# SAMPLE REPORT

## Sample Project Thermal Roof Assessment

## Thermal Analysis Issue Report

Captured on March 9, 2024

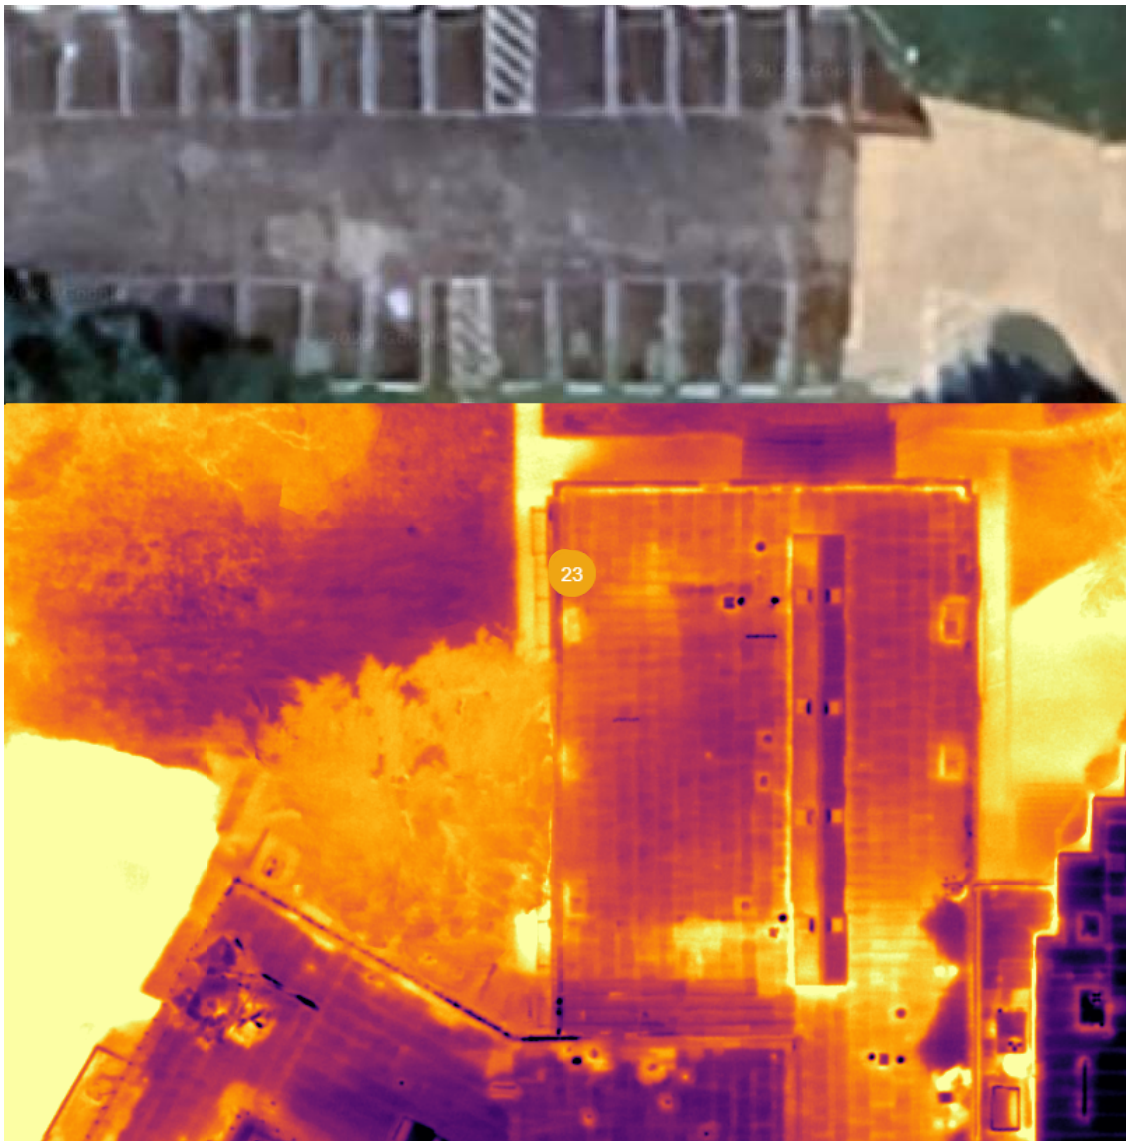
23 - Observation

Summary:	Thermal anomaly pattern typical of moisture under membrane at markers. Further investigation is recommended by a qualified professional roofer to verify.		
Created:	Mar 13, 2024, 6:37pm by Jay Bowen		
Cost of Repair:	—		
Lat/Long:	32.89067, -97.15382		
Area:	14.45 ft <sup>2</sup>		
Radius:	2.14 ft		
Perimeter:	13.47 ft

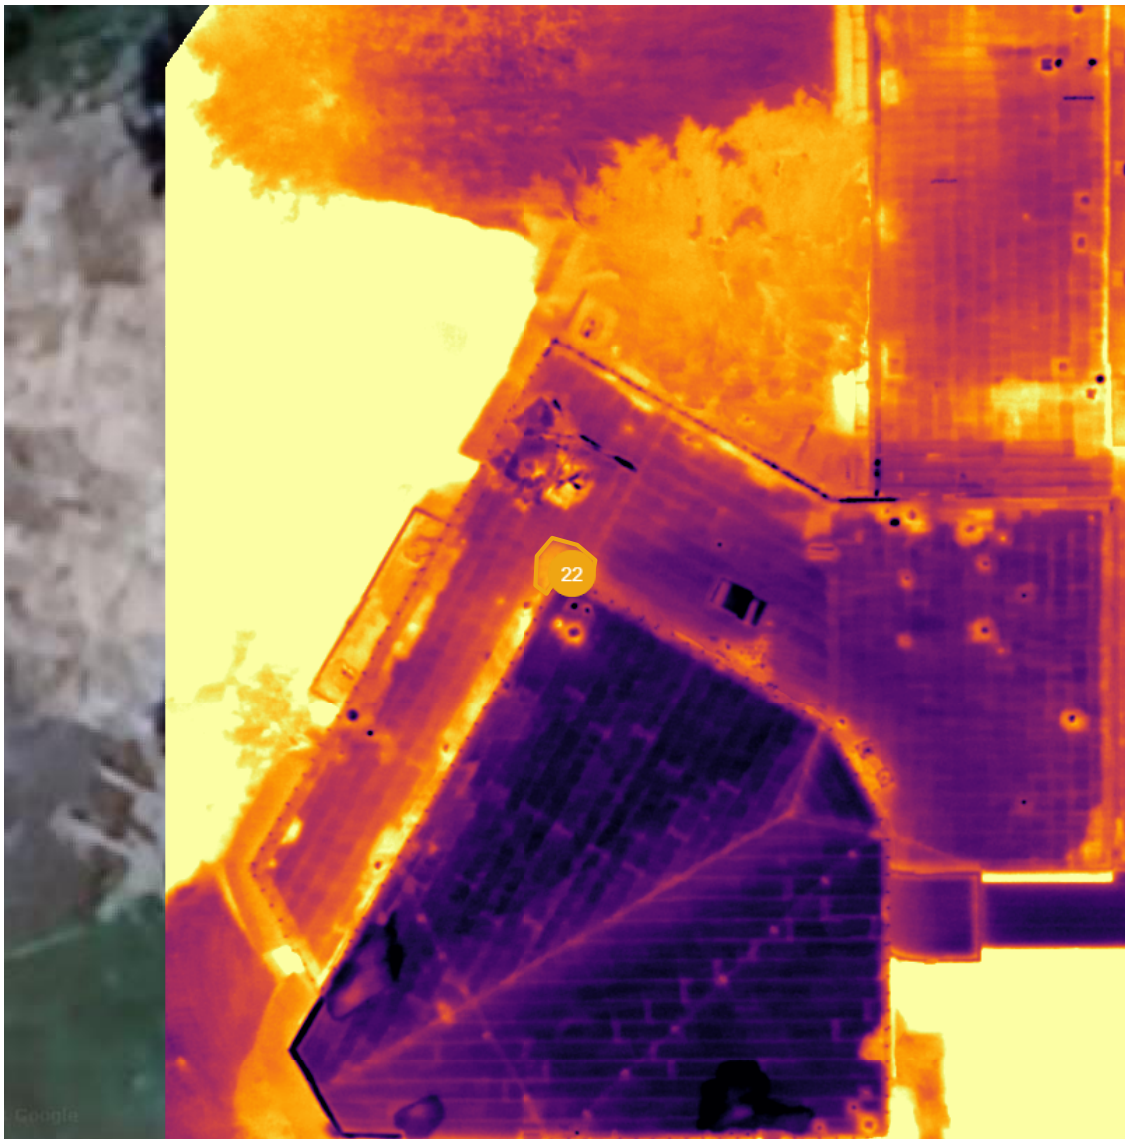
22 - Observation

Summary:	Thermal anomaly pattern typical of moisture under membrane at markers. Further investigation is recommended by a qualified professional roofer to verify.		
Created:	Mar 13, 2024, 6:37pm by Jay Bowen		
Cost of Repair:	—		
Lat/Long:	32.89045, -97.15397		
Area:	42.86 ft <sup>2</sup>		
Surface area:	89.05 ft <sup>2</sup>

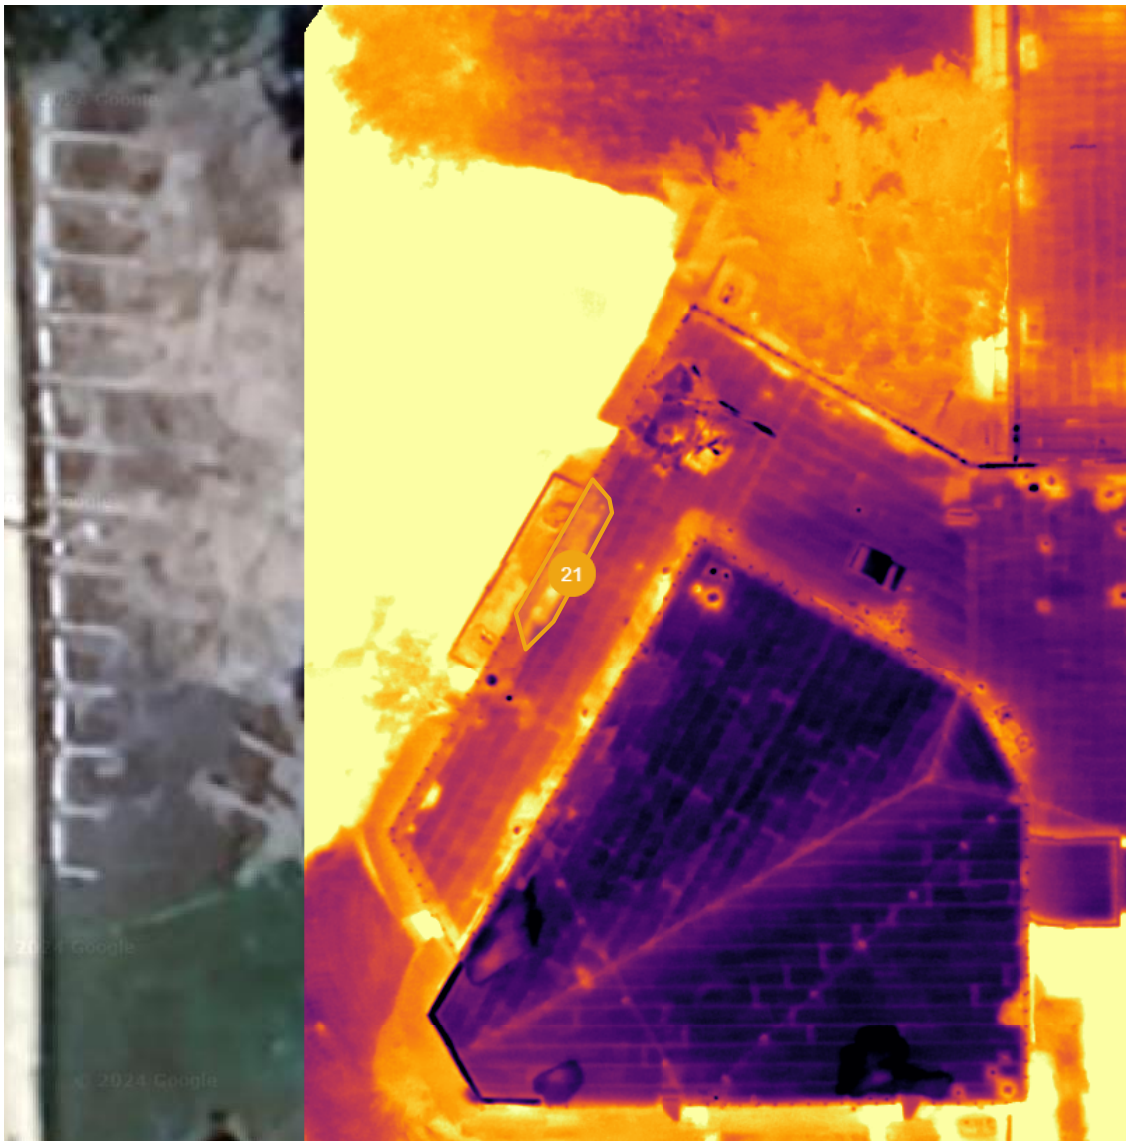
21 - Observation

Summary:	Thermal anomaly pattern typical of moisture under membrane at markers. Further investigation is recommended by a qualified professional roofer to verify.		
Created:	Mar 13, 2024, 6:37pm by Jay Bowen		
Cost of Repair:	—		
Lat/Long:	32.89044, -97.15403		
Area:	122.19 ft <sup>2</sup>		
Surface area:	153.01 ft <sup>2</sup>

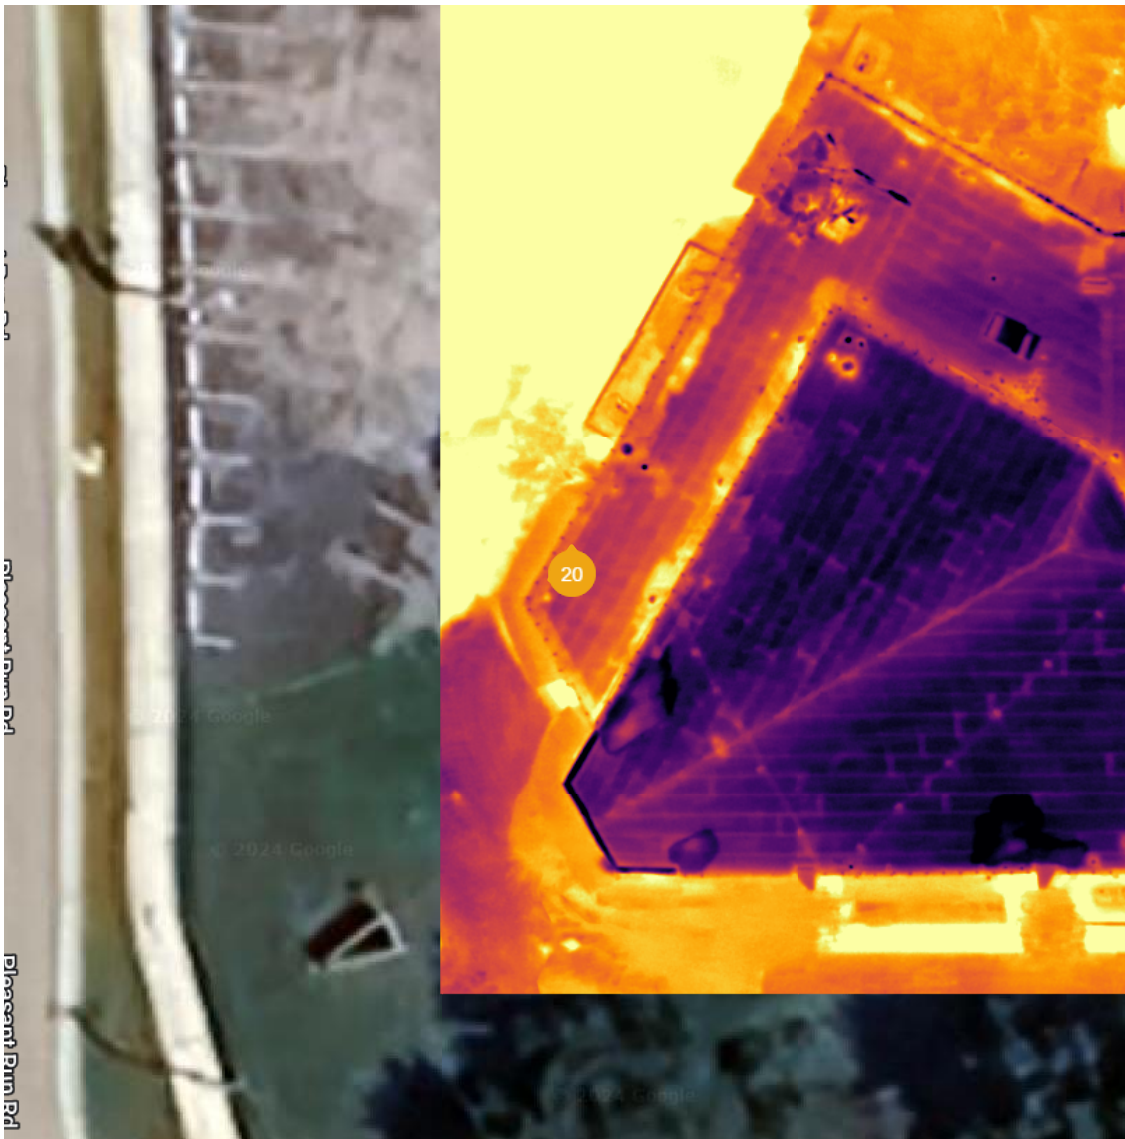
20 - Observation

Summary:	Thermal anomaly pattern typical of moisture under membrane at markers. Further investigation is recommended by a qualified professional roofer to verify.		
Created:	Mar 13, 2024, 6:37pm by Jay Bowen		
Cost of Repair:	—		
Lat/Long:	32.89035, -97.15410		
Area:	12.27 ft <sup>2</sup>		
Surface area:	17.65 ft <sup>2</sup>

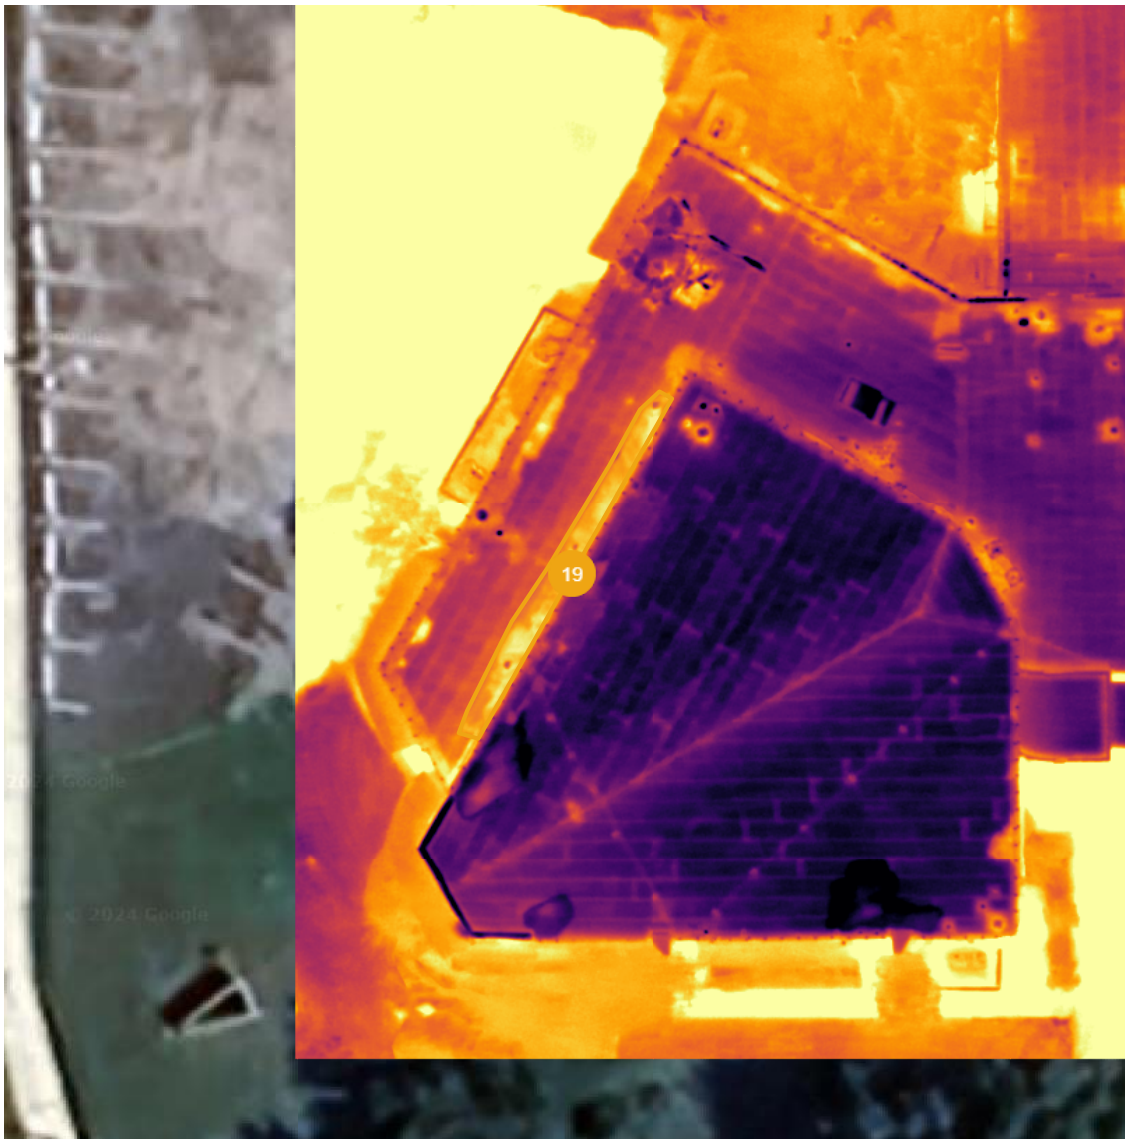
19 - Observation

Summary:	Thermal anomaly pattern typical of moisture under membrane at markers. Further investigation is recommended by a qualified professional roofer to verify.		
Created:	Mar 13, 2024, 6:37pm by Jay Bowen		
Cost of Repair:	—		
Lat/Long:	32.89037, -97.15404		
Area:	200.07 ft <sup>2</sup>		
Surface area:	521.22 ft <sup>2</sup>

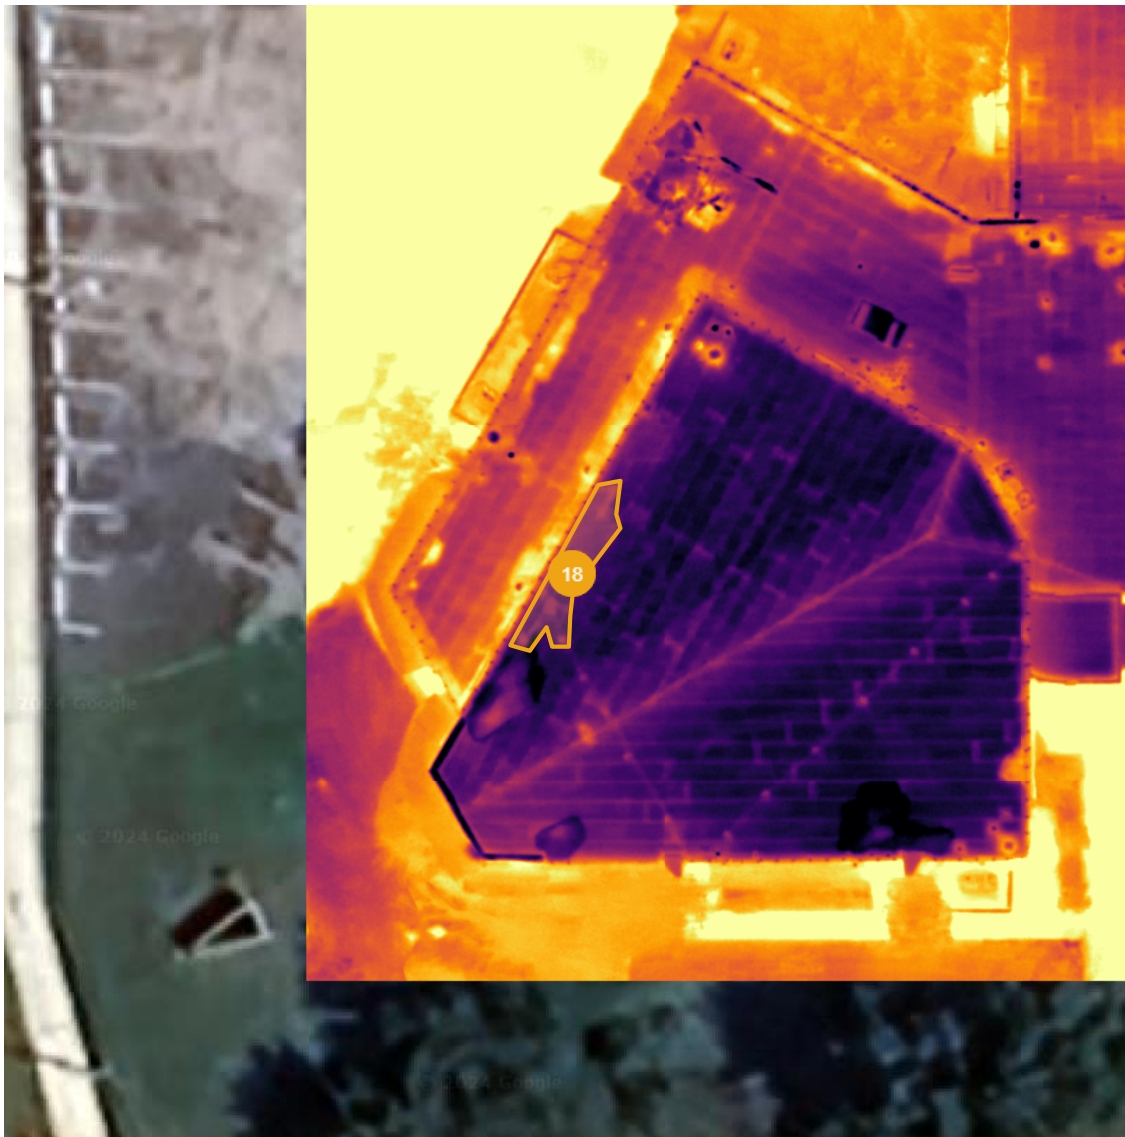
18 - Observation

Summary:	Thermal anomaly pattern typical of moisture under membrane at markers. Further investigation is recommended by a qualified professional roofer to verify.		
Created:	Mar 13, 2024, 6:36pm by Jay Bowen		
Cost of Repair:	—		
Lat/Long:	32.89034, -97.15403		
Area:	136.98 ft <sup>2</sup>		
Surface area:	163.05 ft <sup>2</sup>

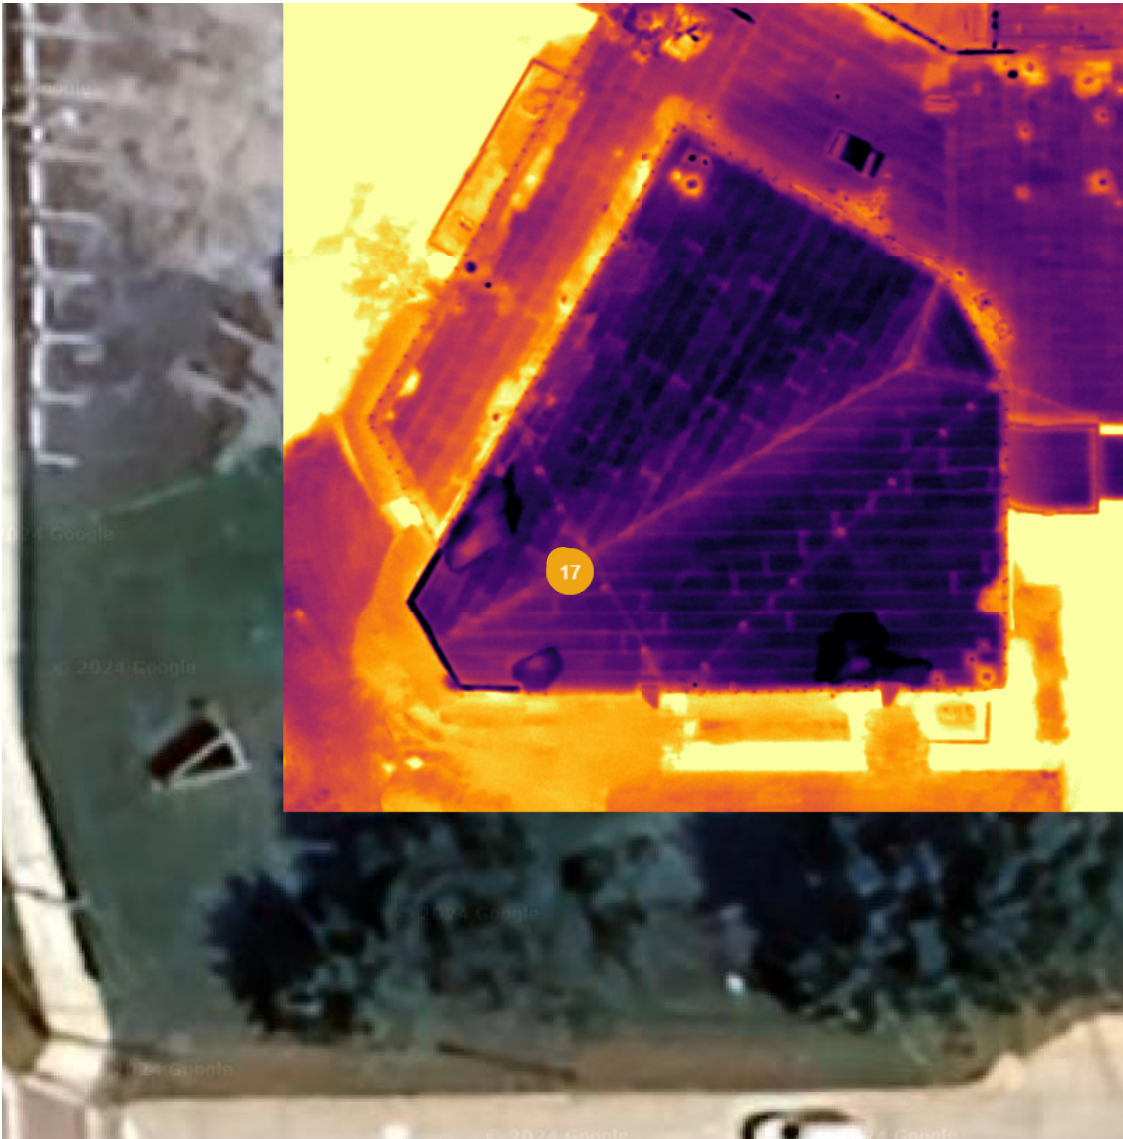
17 - Observation

Summary:	Thermal anomaly pattern typical of moisture under membrane at markers. Further investigation is recommended by a qualified professional roofer to verify.		
Created:	Mar 13, 2024, 6:36pm by Jay Bowen		
Cost of Repair:	—		
Lat/Long:	32.89027, -97.15403		
Area:	12.89 ft <sup>2</sup>		
Radius:	2.03 ft		
Perimeter:	12.73 ft

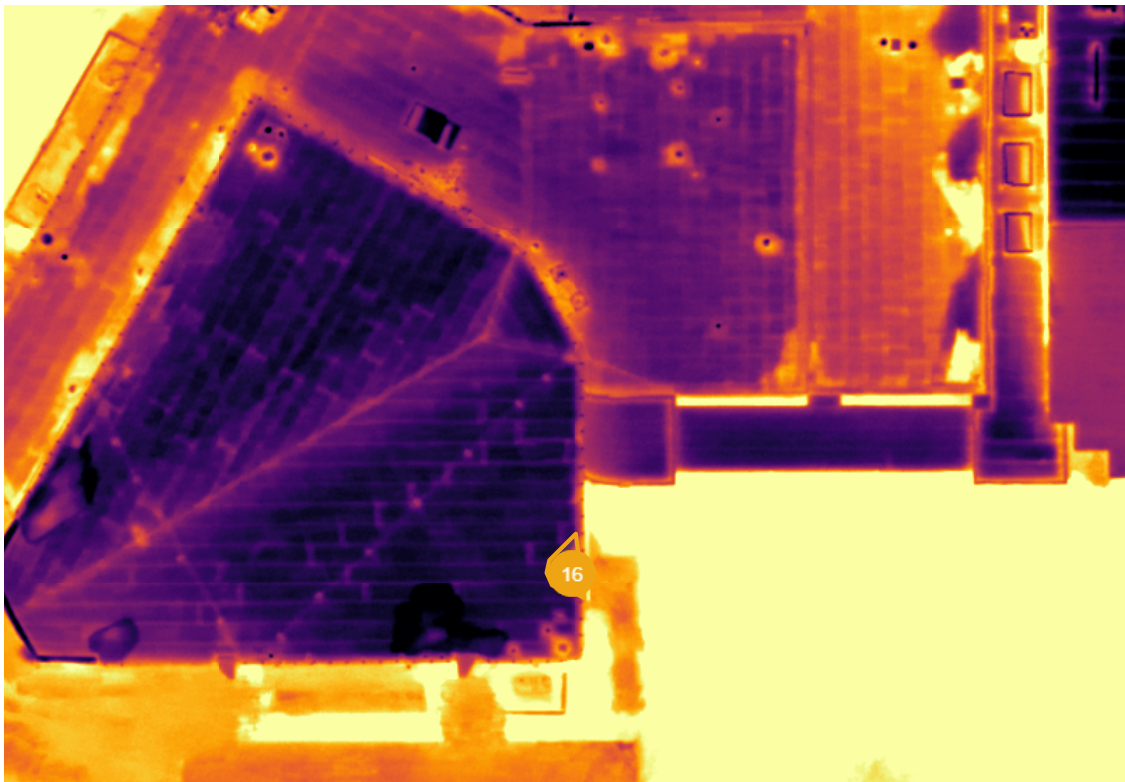
16 - Observation

Summary:	Thermal anomaly pattern typical of moisture under membrane at markers. Further investigation is recommended by a qualified professional roofer to verify.		
Created:	Mar 13, 2024, 6:36pm by Jay Bowen		
Cost of Repair:	—		
Lat/Long:	32.89026, -97.15382		
Area:	29.52 ft <sup>2</sup>		
Surface area:	29.97 ft <sup>2</sup>

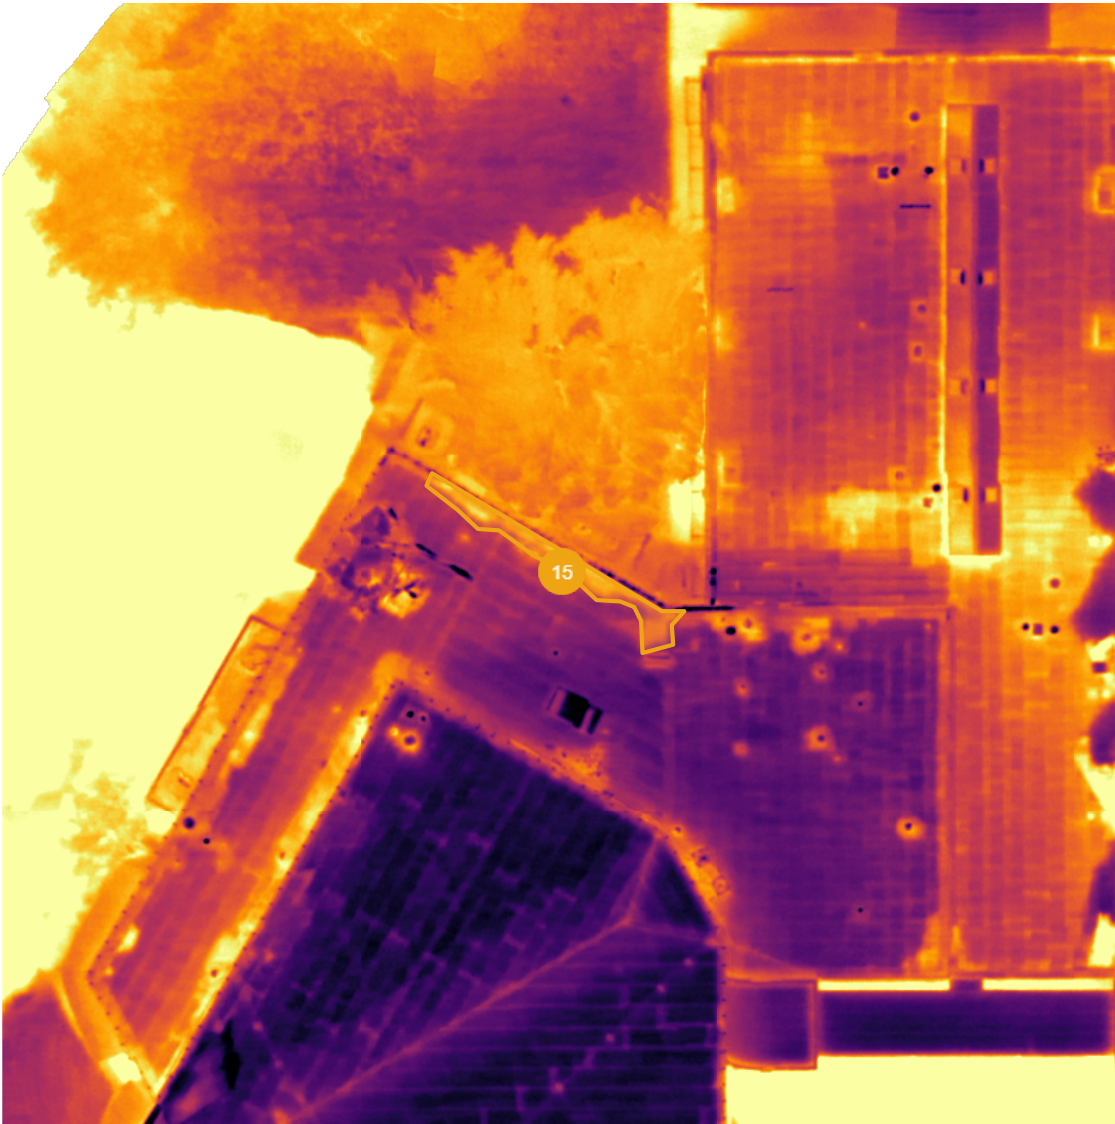
15 - Observation

Summary:	Thermal anomaly pattern typical of moisture under membrane at markers. Further investigation is recommended by a qualified professional roofer to verify.		
Created:	Mar 13, 2024, 6:36pm by Jay Bowen		
Cost of Repair:	—		
Lat/Long:	32.89049, -97.15388		
Area:	122.20 ft <sup>2</sup>		
Surface area:	167.23 ft <sup>2</sup>

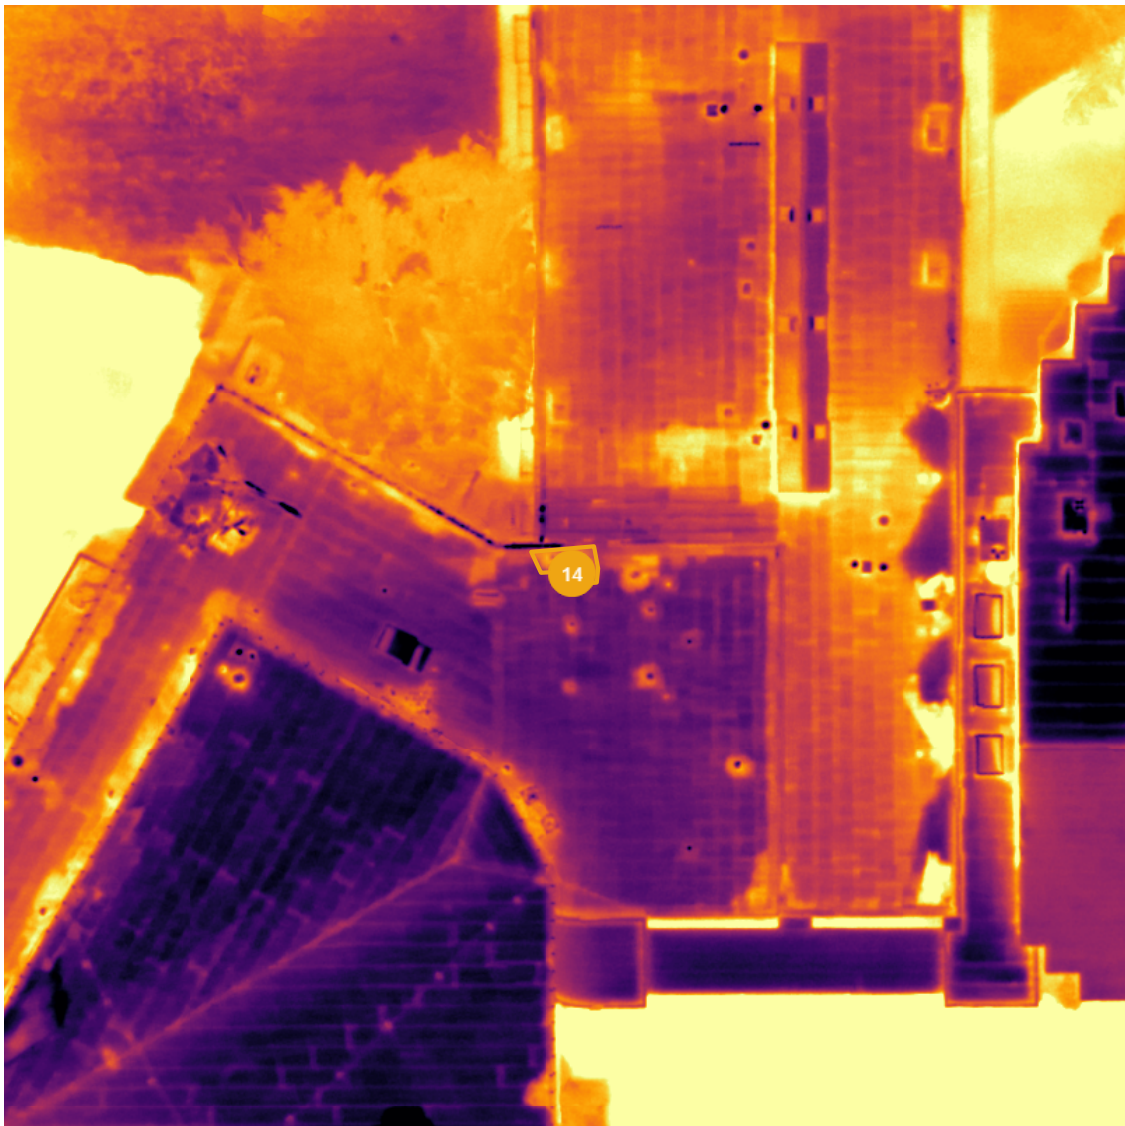
14 - Observation

Summary:	Thermal anomaly pattern typical of moisture under membrane at markers. Further investigation is recommended by a qualified professional roofer to verify.		
Created:	Mar 13, 2024, 6:36pm by Jay Bowen		
Cost of Repair:	—		
Lat/Long:	32.89047, -97.15380		
Area:	37.55 ft <sup>2</sup>		
Surface area:	50.25 ft <sup>2</sup>

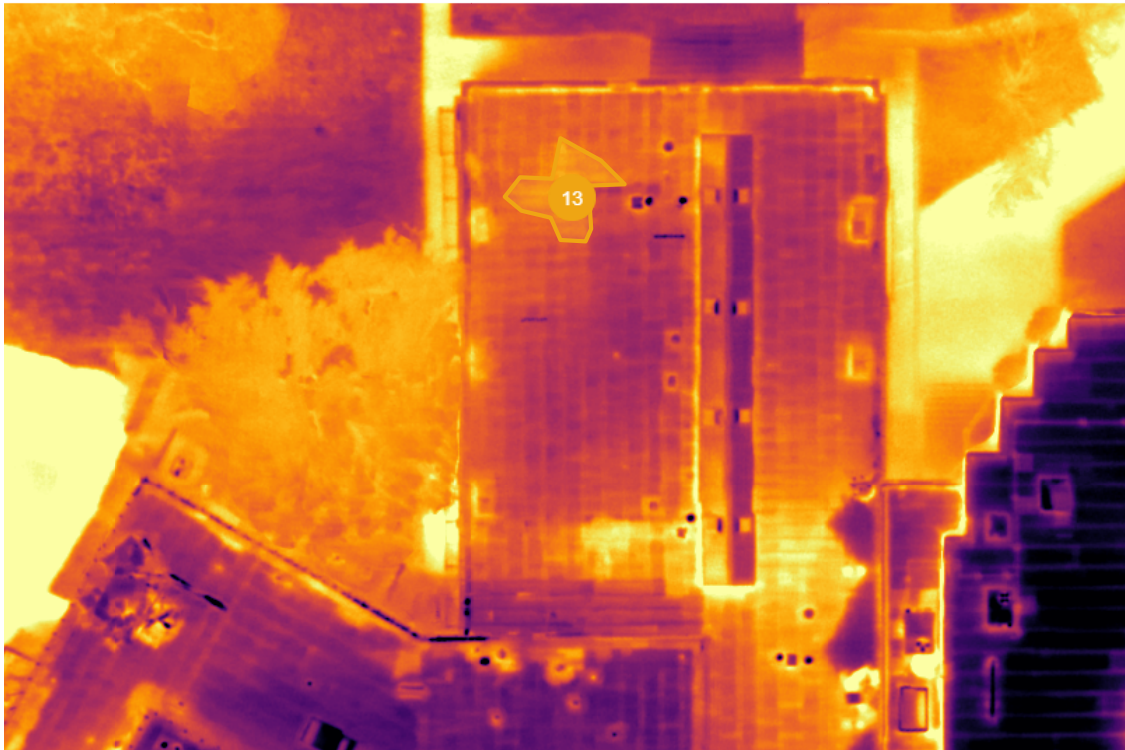
13 - Observation

Summary:	Thermal anomaly pattern typical of moisture under membrane at markers. Further investigation is recommended by a qualified professional roofer to verify.		
Created:	Mar 13, 2024, 6:36pm by Jay Bowen		
Cost of Repair:	—		
Lat/Long:	32.89066, -97.15377		
Area:	117.60 ft <sup>2</sup>		
Surface area:	137.29 ft <sup>2</sup>

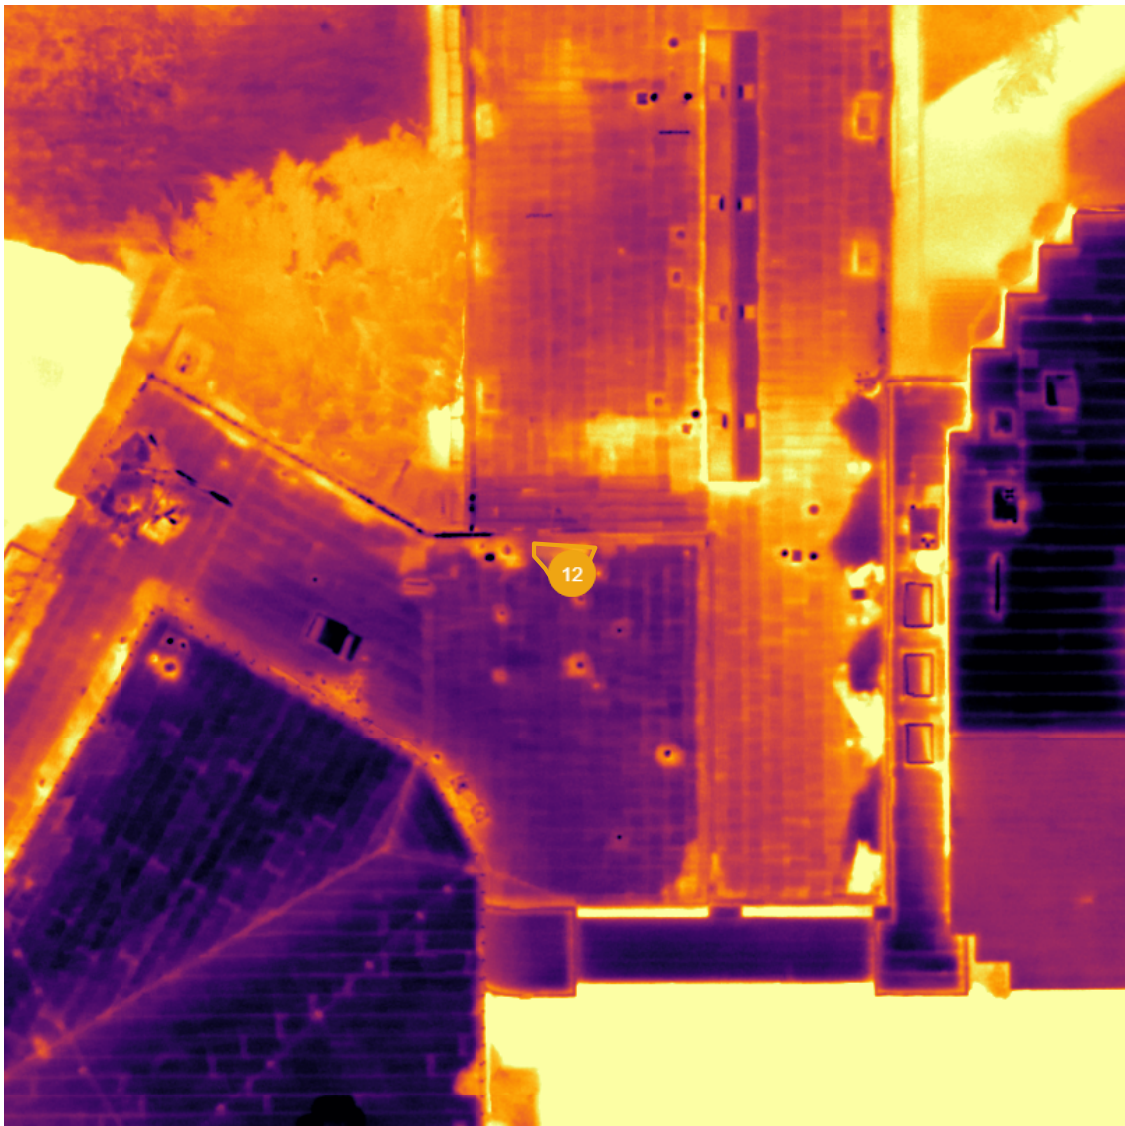
12 - Observation

Summary:	Thermal anomaly pattern typical of moisture under membrane at markers. Further investigation is recommended by a qualified professional roofer to verify.		
Created:	Mar 13, 2024, 6:36pm by Jay Bowen		
Cost of Repair:	—		
Lat/Long:	32.89047, -97.15378		
Area:	37.59 ft <sup>2</sup>		
Surface area:	47.61 ft <sup>2</sup>

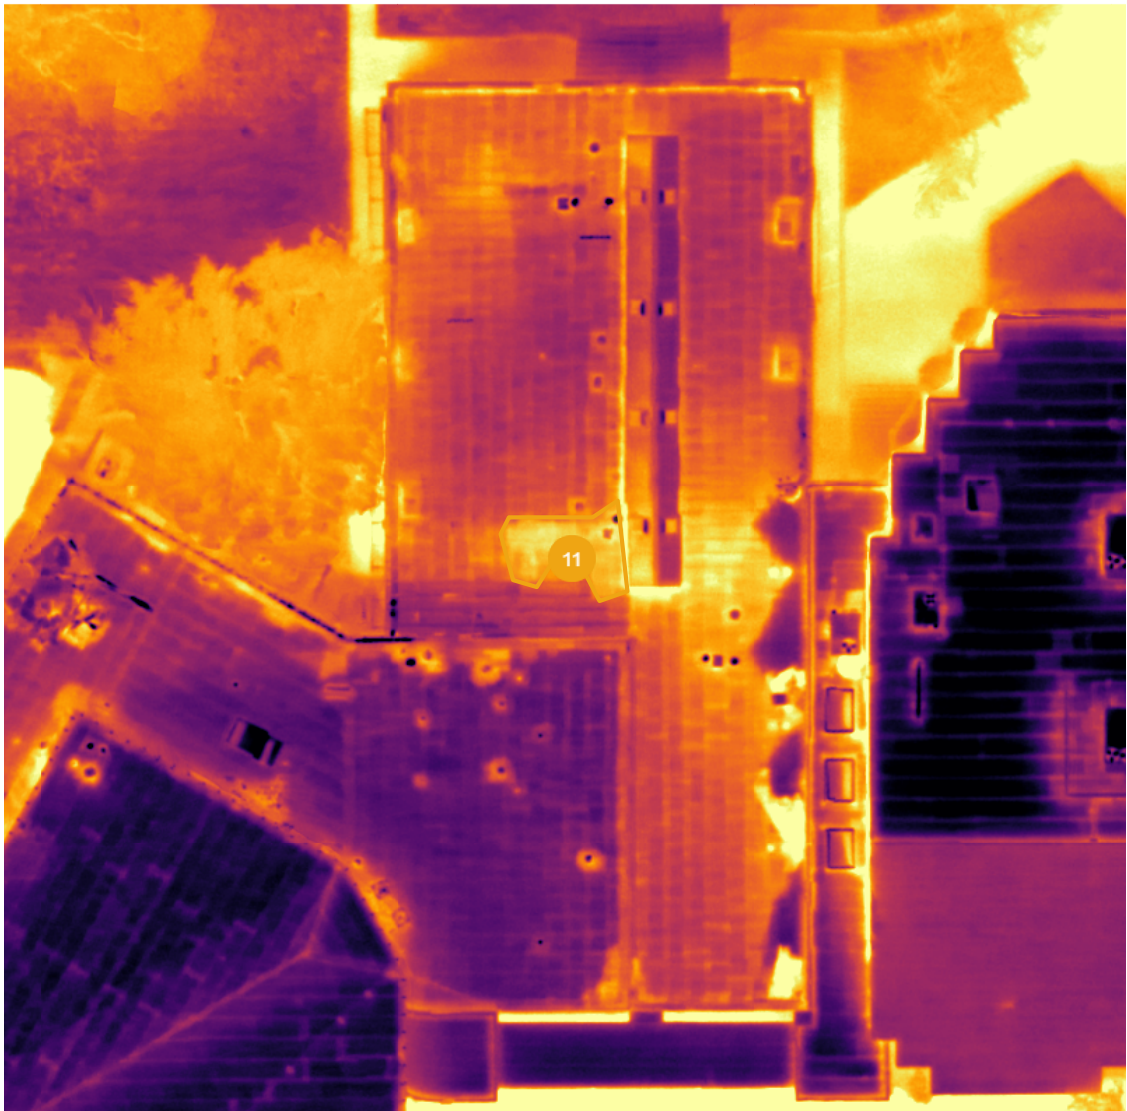
11 - Observation

Summary:	Thermal anomaly pattern typical of moisture under membrane at markers. Further investigation is recommended by a qualified professional roofer to verify.		
Created:	Mar 13, 2024, 6:36pm by Jay Bowen		
Cost of Repair:	—		
Lat/Long:	32.89052, -97.15374		
Area:	169.52 ft <sup>2</sup>		
Surface area:	169.47 ft <sup>2</sup>

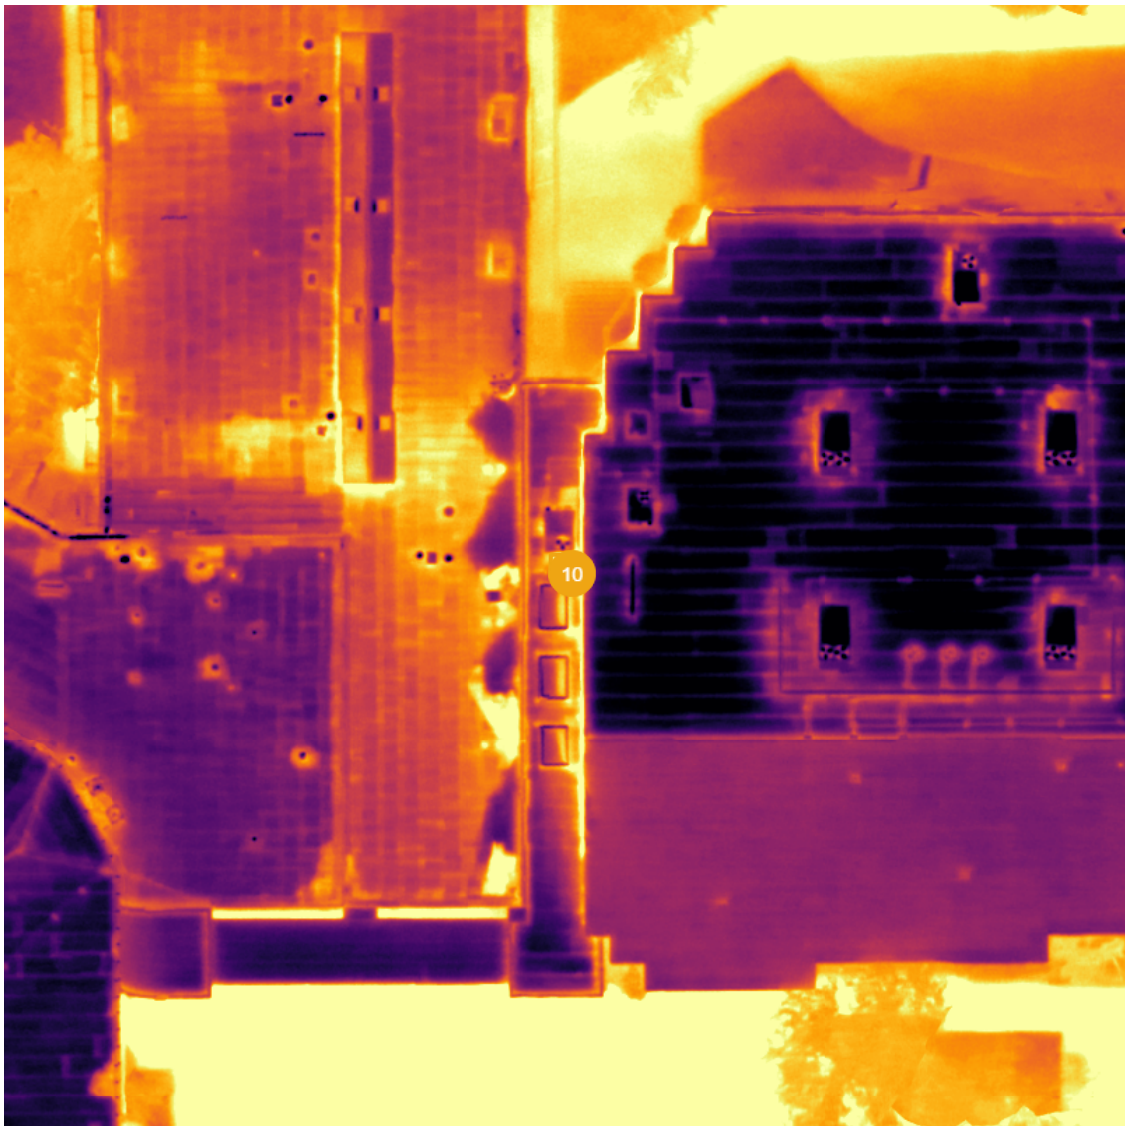
10 - Observation

Summary:	Thermal anomaly pattern typical of moisture under membrane at markers. Further investigation is recommended by a qualified professional roofer to verify.		
Created:	Mar 13, 2024, 6:35pm by Jay Bowen		
Cost of Repair:	—		
Lat/Long:	32.89047, -97.15360		
Area:	14.27 ft <sup>2</sup>		
Surface area:	76.51 ft <sup>2</sup>

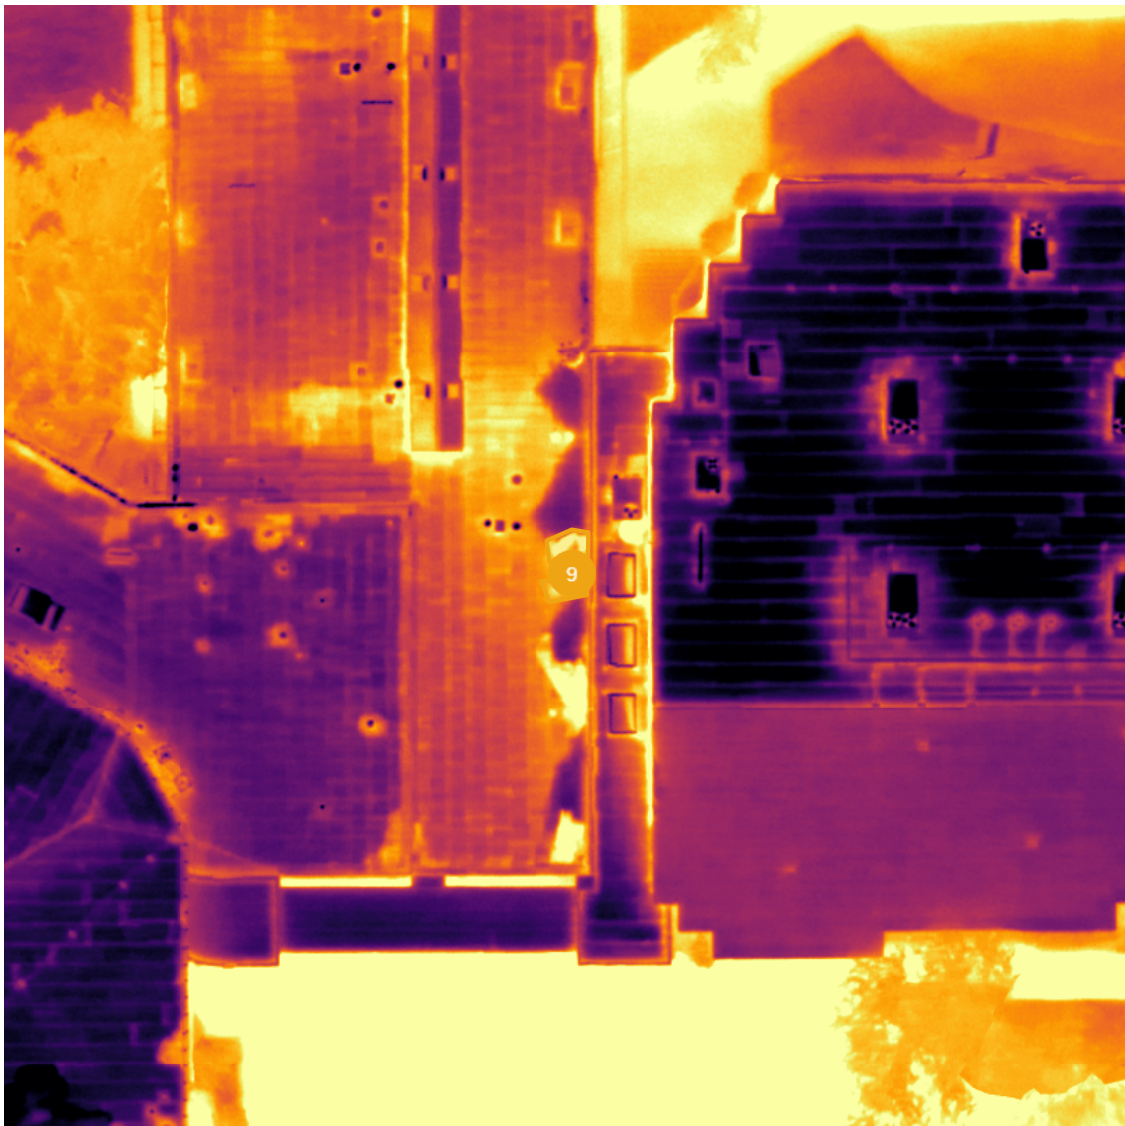
9 - Observation

Summary:	Thermal anomaly pattern typical of moisture under membrane at markers. Further investigation is recommended by a qualified professional roofer to verify.		
Created:	Mar 13, 2024, 6:35pm by Jay Bowen		
Cost of Repair:	—		
Lat/Long:	32.89046, -97.15363		
Area:	52.39 ft <sup>2</sup>		
Surface area:	100.74 ft <sup>2</sup>

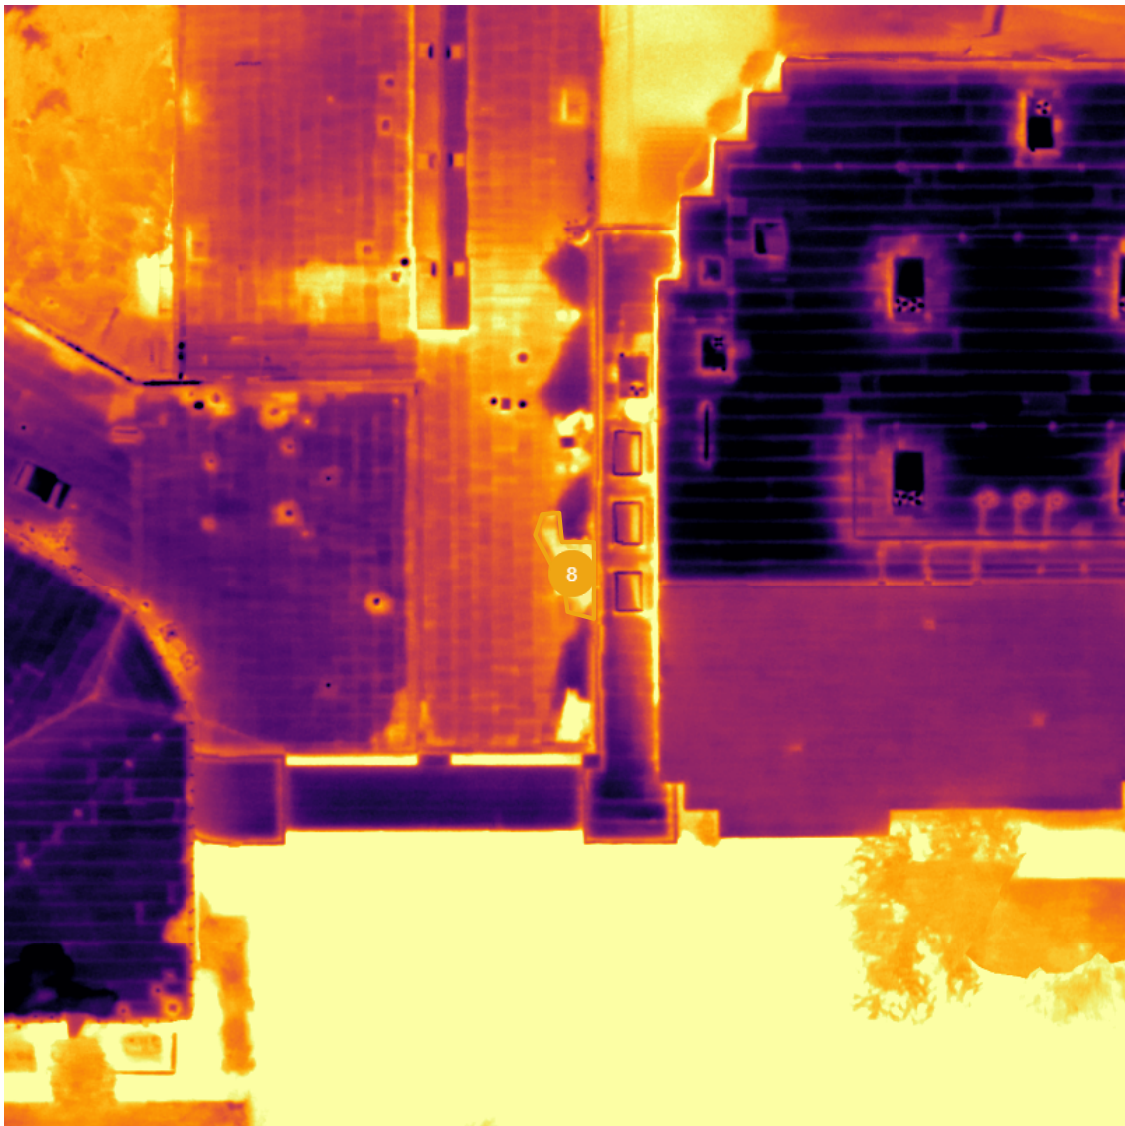
8 - Observation

Summary:	Thermal anomaly pattern typical of moisture under membrane at markers. Further investigation is recommended by a qualified professional roofer to verify.		
Created:	Mar 13, 2024, 6:35pm by Jay Bowen		
Cost of Repair:	—		
Lat/Long:	32.89041, -97.15363		
Area:	73.06 ft <sup>2</sup>		
Surface area:	106.17 ft <sup>2</sup>

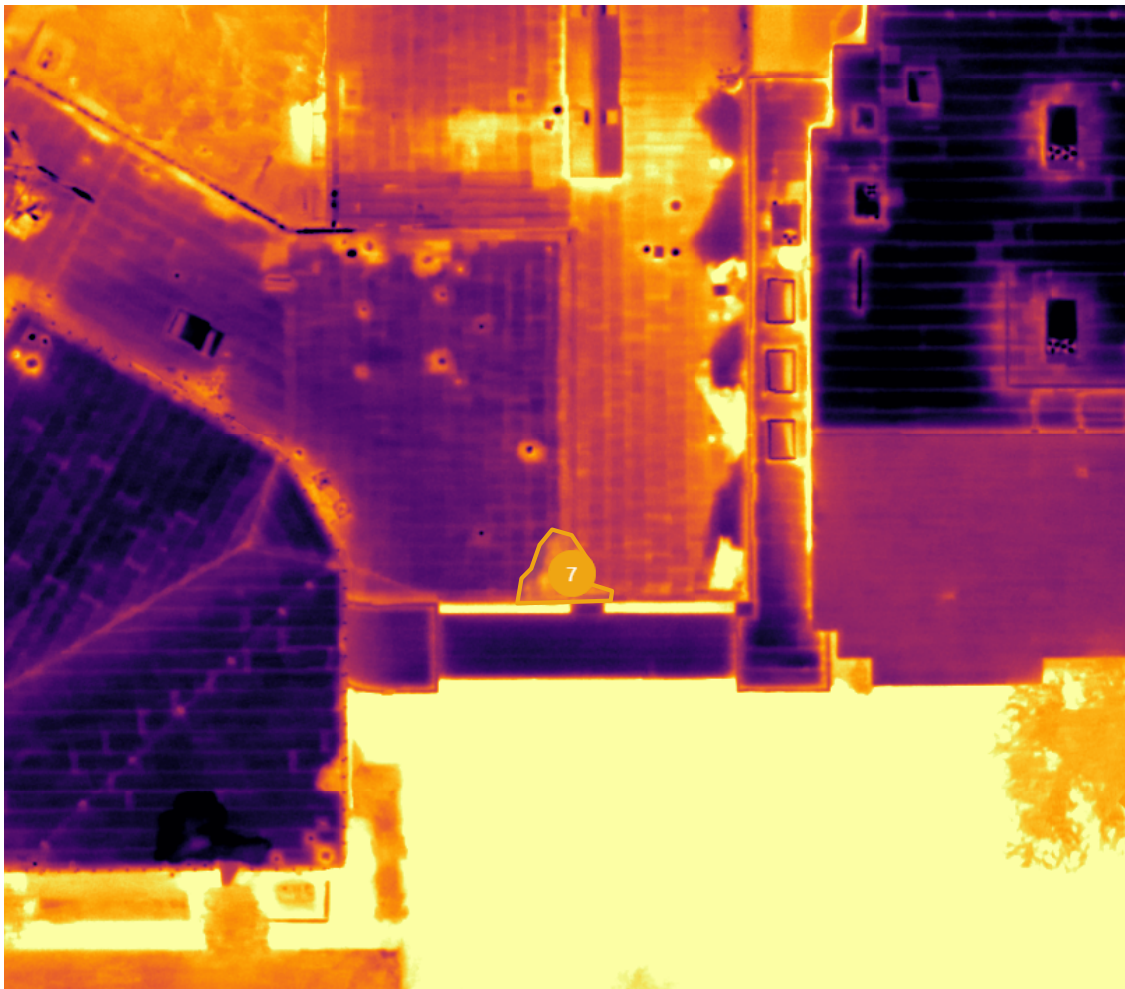
7 - Observation

Summary:	Thermal anomaly pattern typical of moisture under membrane at markers. Further investigation is recommended by a qualified professional roofer to verify.		
Created:	Mar 13, 2024, 6:35pm by Jay Bowen		
Cost of Repair:	—		
Lat/Long:	32.89034, -97.15371		
Area:	91.14 ft <sup>2</sup>		
Surface area:	99.73 ft <sup>2</sup>
