# SAMPLE REPORT

## Sample Project Thermal Roof Assessment

## Thermal Analysis Issue Report

Captured on March 9, 2024

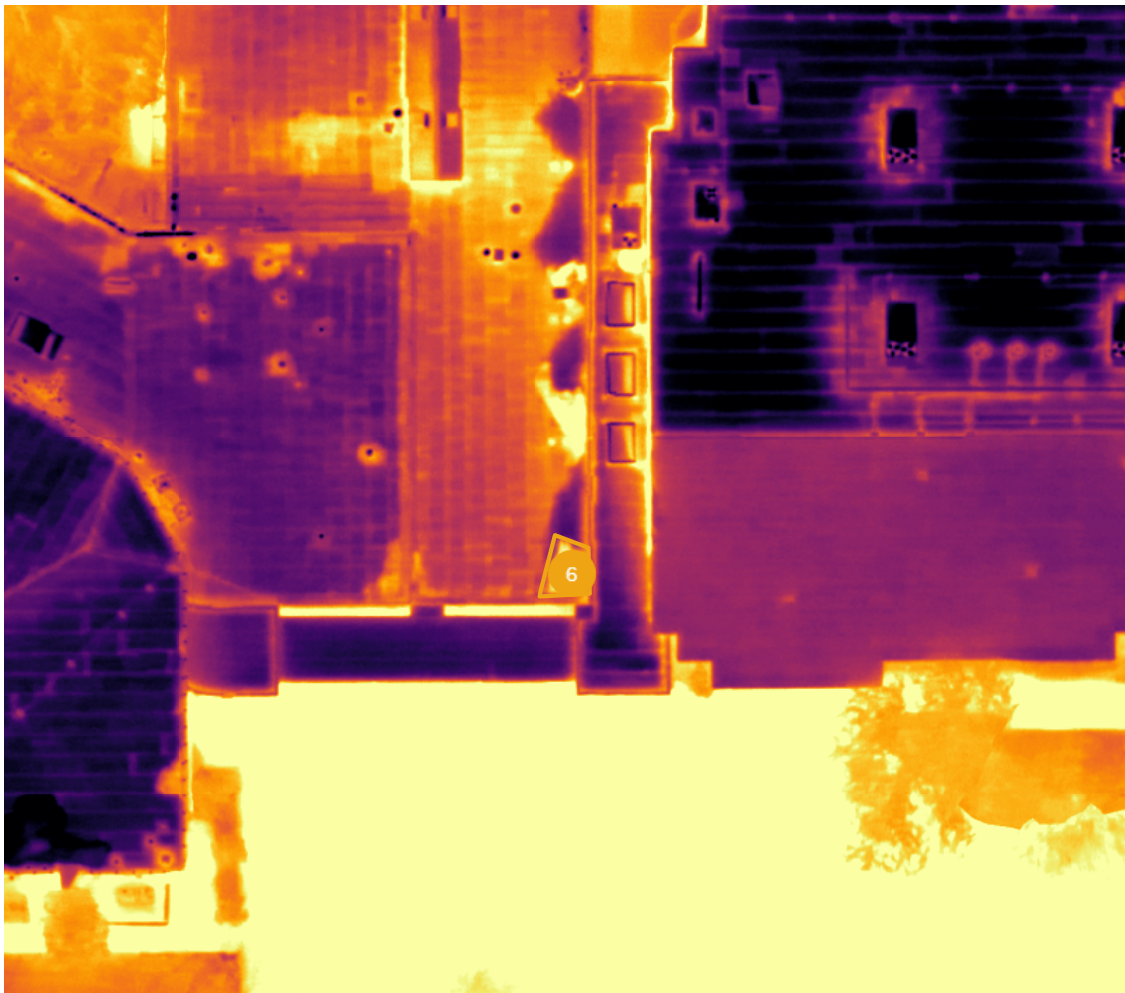
6 - Observation

Summary:	Thermal anomaly pattern typical of moisture under membrane at markers. Further investigation is recommended by a qualified professional roofer to verify.		
Created:	Mar 13, 2024, 6:35pm by Jay Bowen		
Cost of Repair:	—		
Lat/Long:	32.89034, -97.15363		
Area:	49.59 ft <sup>2</sup>		
Surface area:	82.34 ft <sup>2</sup>

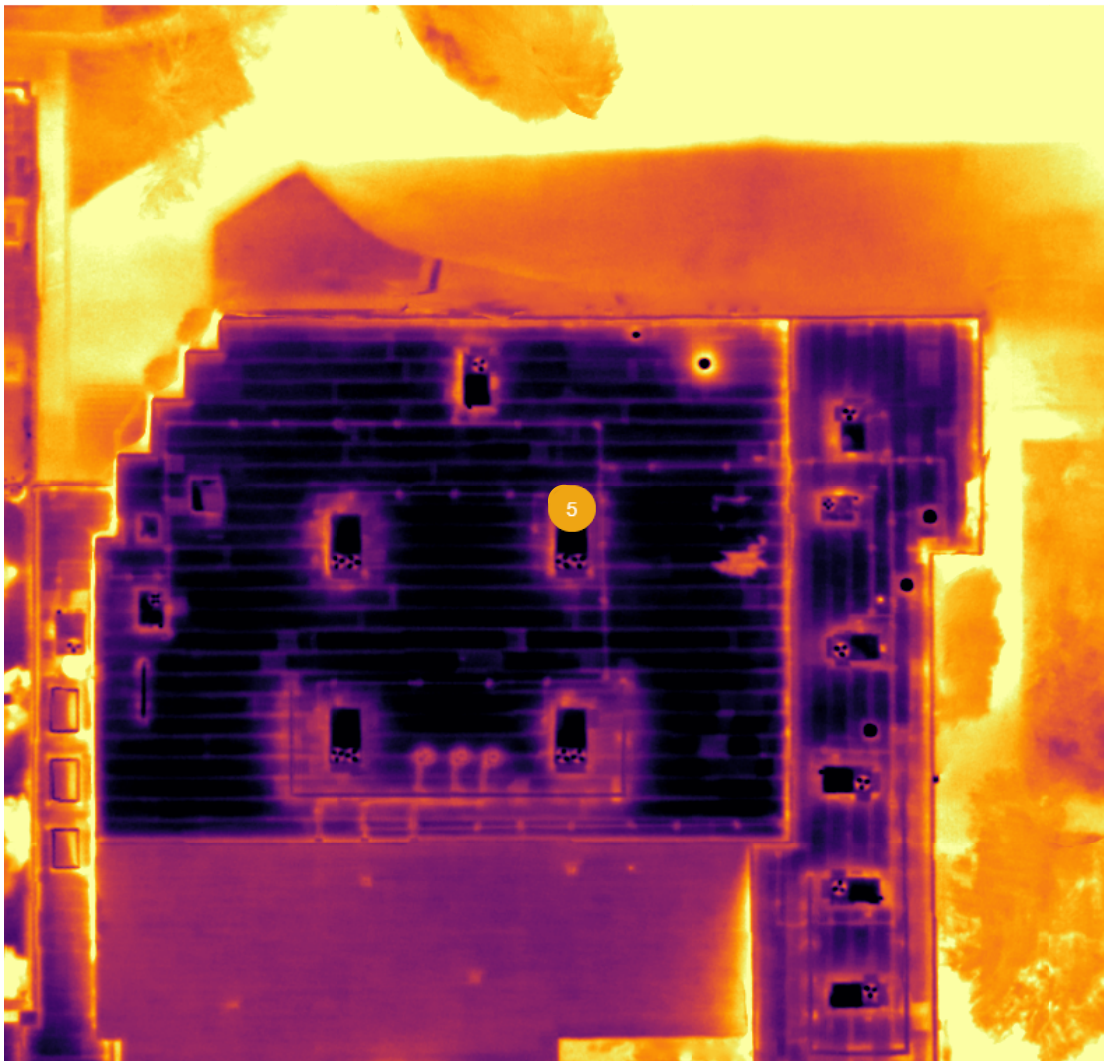
5 - Observation

Summary:	Thermal anomaly pattern typical of moisture under membrane at markers. Further investigation is recommended by a qualified professional roofer to verify.		
Created:	Mar 13, 2024, 6:35pm by Jay Bowen		
Cost of Repair:	—		
Lat/Long:	32.89054, -97.15336		
Area:	13.26 ft <sup>2</sup>		
Radius:	2.05 ft		
Perimeter:	12.91 ft

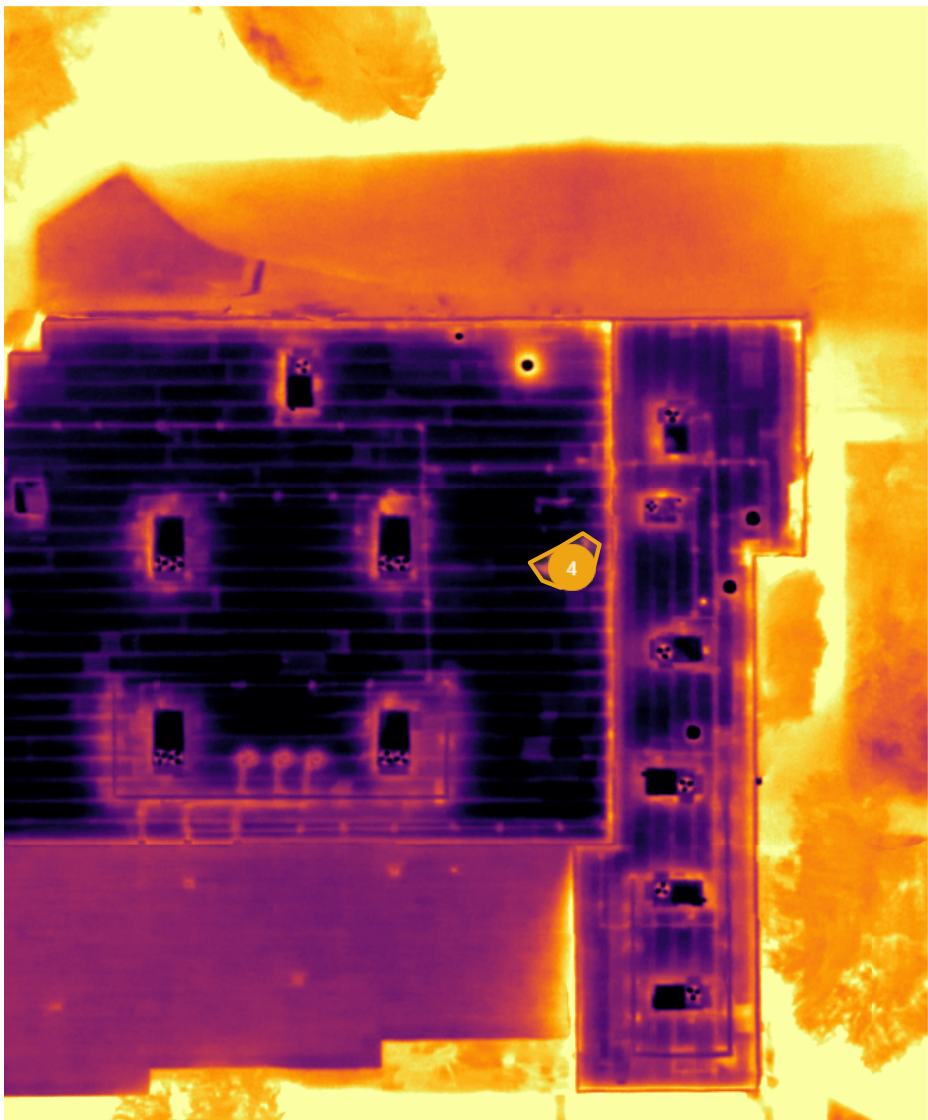
4 - Observation

Summary:	Thermal anomaly pattern typical of moisture under membrane at markers. Further investigation is recommended by a qualified professional roofer to verify.		
Created:	Mar 13, 2024, 6:35pm by Jay Bowen		
Cost of Repair:	—		
Lat/Long:	32.89051, -97.15328		
Area:	49.92 ft <sup>2</sup>		
Surface area:	62.66 ft <sup>2</sup>

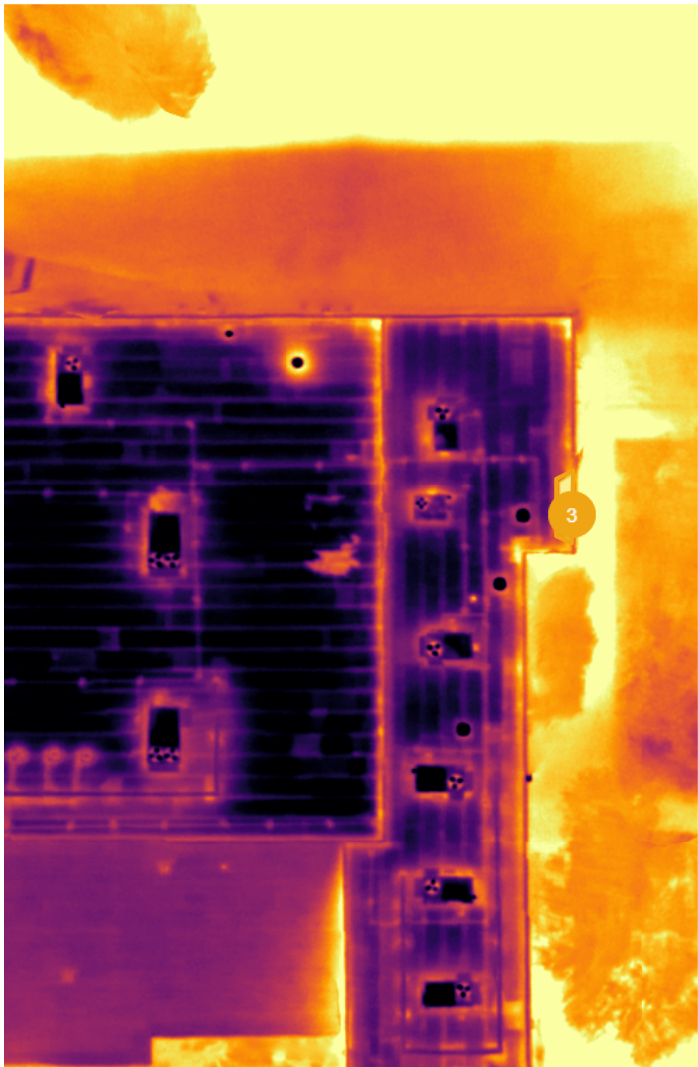
3 - Observation

Summary:	Thermal anomaly pattern typical of moisture under membrane at markers. Further investigation is recommended by a qualified professional roofer to verify.		
Created:	Mar 13, 2024, 6:35pm by Jay Bowen		
Cost of Repair:	—		
Lat/Long:	32.89053, -97.15317		
Area:	22.36 ft <sup>2</sup>		
Surface area:	70.10 ft <sup>2</sup>

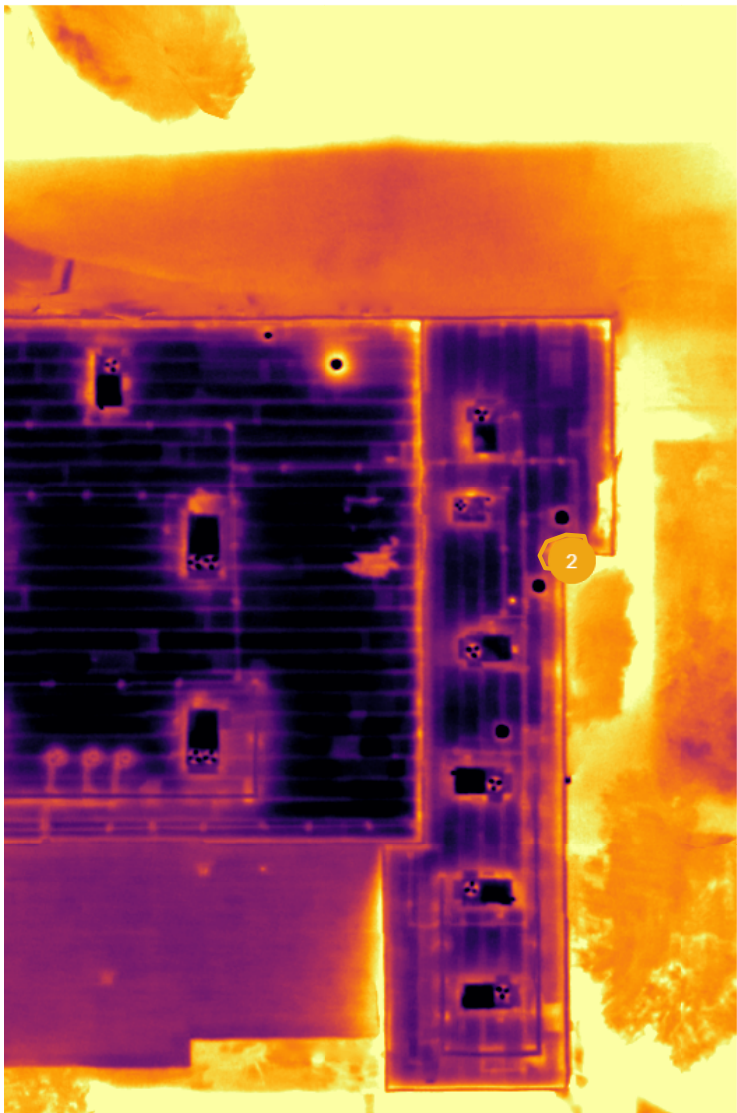
2 - Observation

Summary:	Thermal anomaly pattern typical of moisture under membrane at markers. Further investigation is recommended by a qualified professional roofer to verify.		
Created:	Mar 13, 2024, 6:34pm by Jay Bowen		
Cost of Repair:	—		
Lat/Long:	32.89052, -97.15319		
Area:	22.33 ft <sup>2</sup>		
Surface area:	30.32 ft <sup>2</sup>

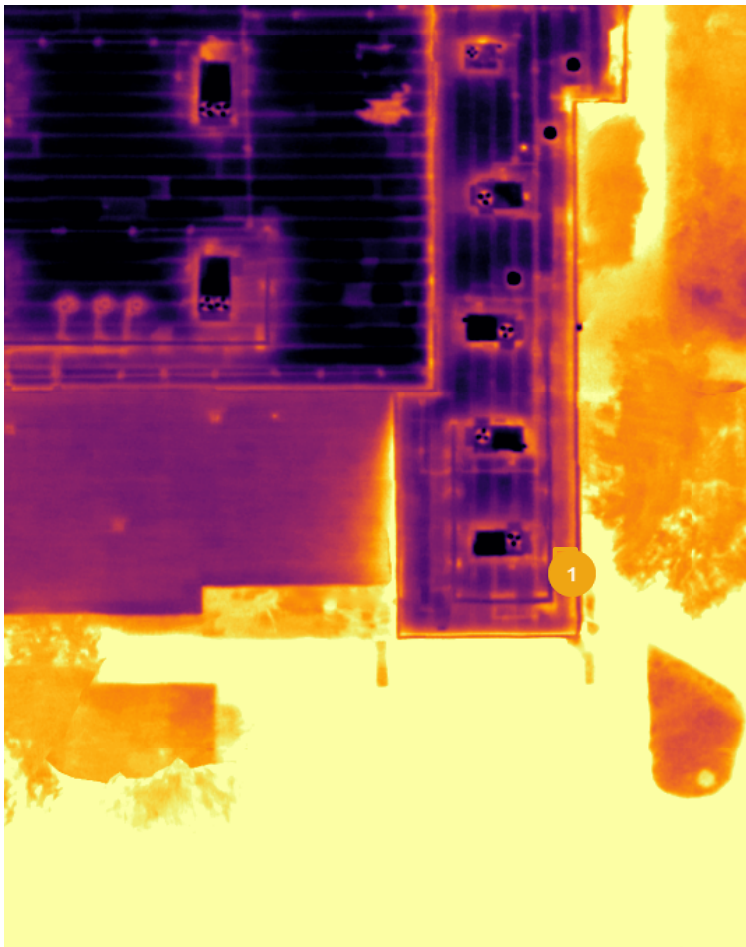
1 - Observation

Summary:	Thermal anomaly pattern typical of moisture under membrane at markers. Further investigation is recommended by a qualified professional roofer to verify.		
Created:	Mar 13, 2024, 6:34pm by Jay Bowen		
Cost of Repair:	—		
Lat/Long:	32.89033, -97.15319		
Area:	14.55 ft <sup>2</sup>		
Surface area:	15.82 ft <sup>2</sup>
