# SAMPLE REPORT

## Sample Project Thermal Roof Assessment

## Thermal Analysis Issue Report

Captured on March 9, 2024

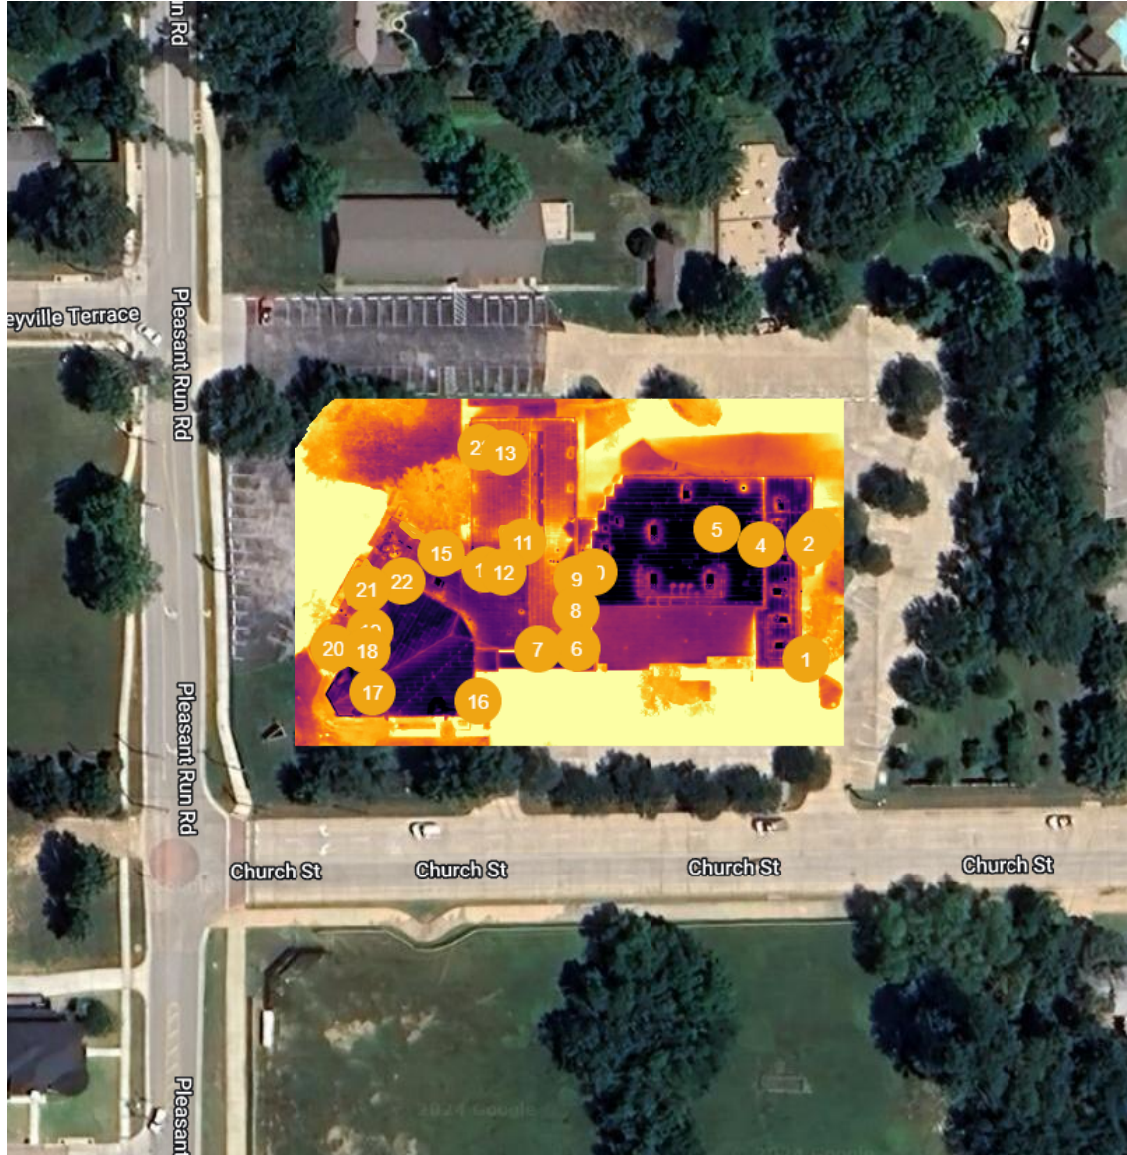
23 - Observation

Open

Summary:	Thermal anomaly pattern typical of moisture under membrane at markers. Further investigation is recommended by a qualified professional roofer to verify.		
Created:	Mar 13, 2024, 6:37pm by Jay Bowen		
Cost of Repair:	—		
Lat/Long:	32.89067, -97.15382		
Area:	14.45 ft <sup>2</sup>		
Radius:	2.14 ft		
Perimeter:	13.47 ft
